Collection of Façade Fire Tests Including Timber Structures

Daniel Brandon

RISE Rapport 2020:50

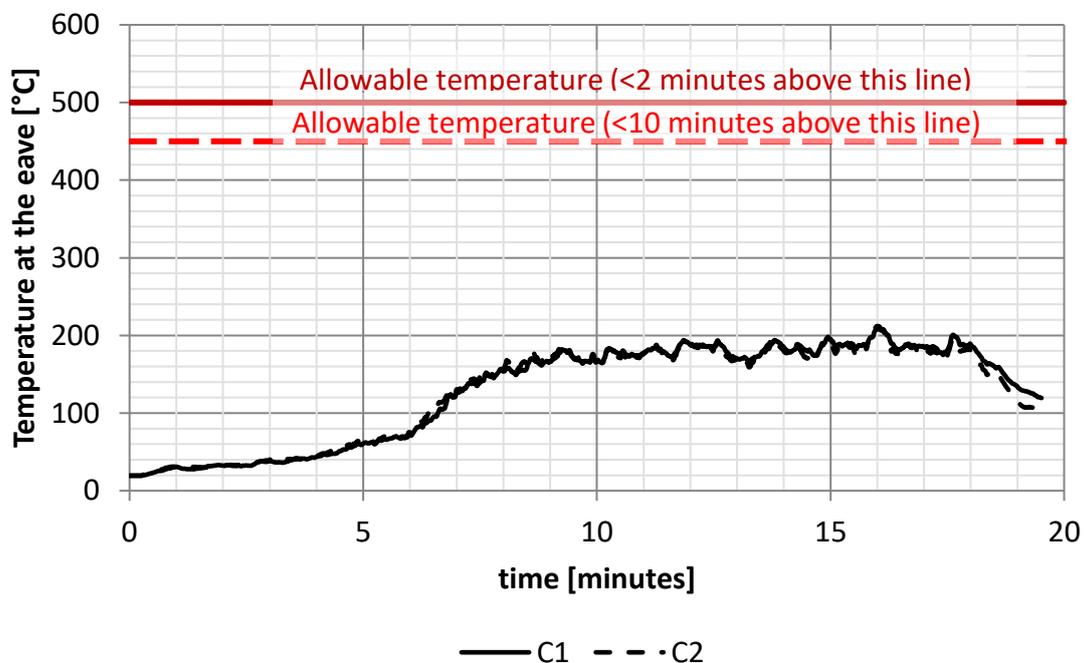
Figure 5: Temperatures at the eave during Test 1 together with the allowable temperatures at that location

- The maximum temperature measured below the eave was 212 °C, which is well under the allowable temperature of 500 °C during a continuous period longer that 2 minutes or 450 °C during a continuous period longer than 10 minutes.
- The heat radiation towards the test specimen in the center of the fictitious window one floor above the fire room did not exceed 80 kW/m² during the test. Maximum measured heat radiation was measured to 30 kW/m².
- During the test, there was no drop-off from the test specimen.
- The fire spread on the surface of the test specimen and inside the test specimen did not reach above the lower edge of the fictitious window two floors above the fire room.

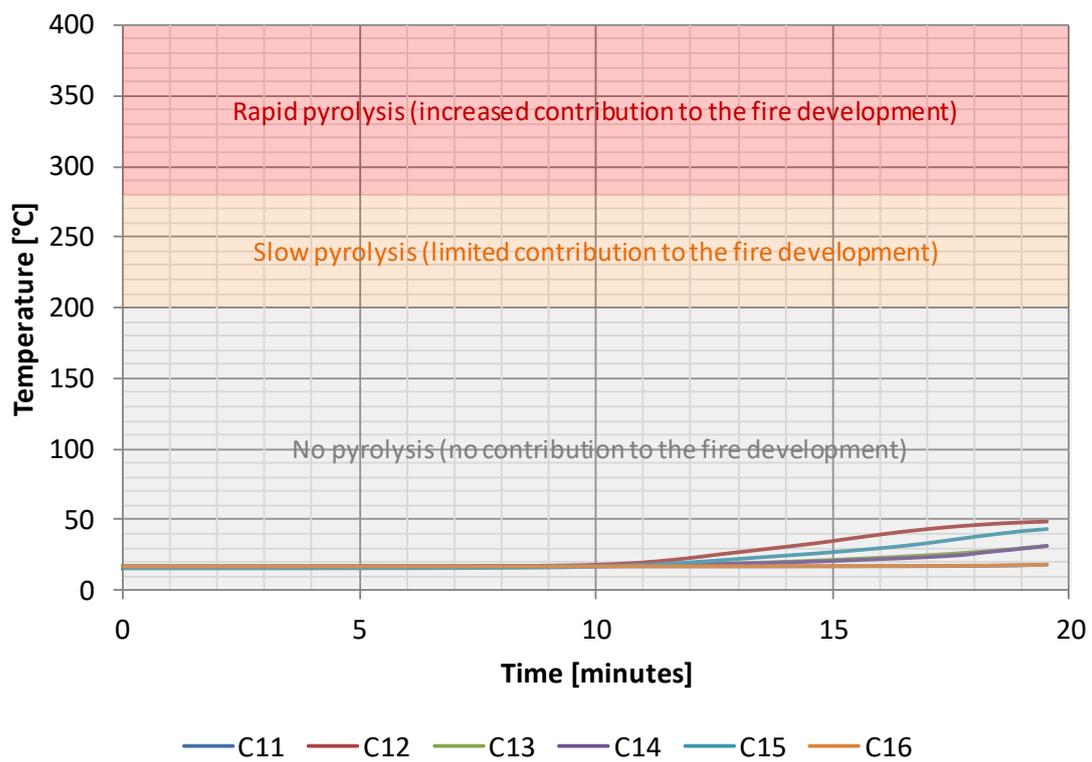
Figure 7: All temperatures measured at the surface of the CLT slab on the side of the fire exposure of Test 1 (locations shown in Figure 2)

Figure 7 shows the temperatures measured on the surface of the CLT on the side of the fire exposure, together with the temperature ranges indicating the wood's contribution to the fire development. The maximum temperature measured on this surface was 48°C, which is well under the pyrolysis temperature, which indicates that the structural timber did not contribute to the fire as a fuel.

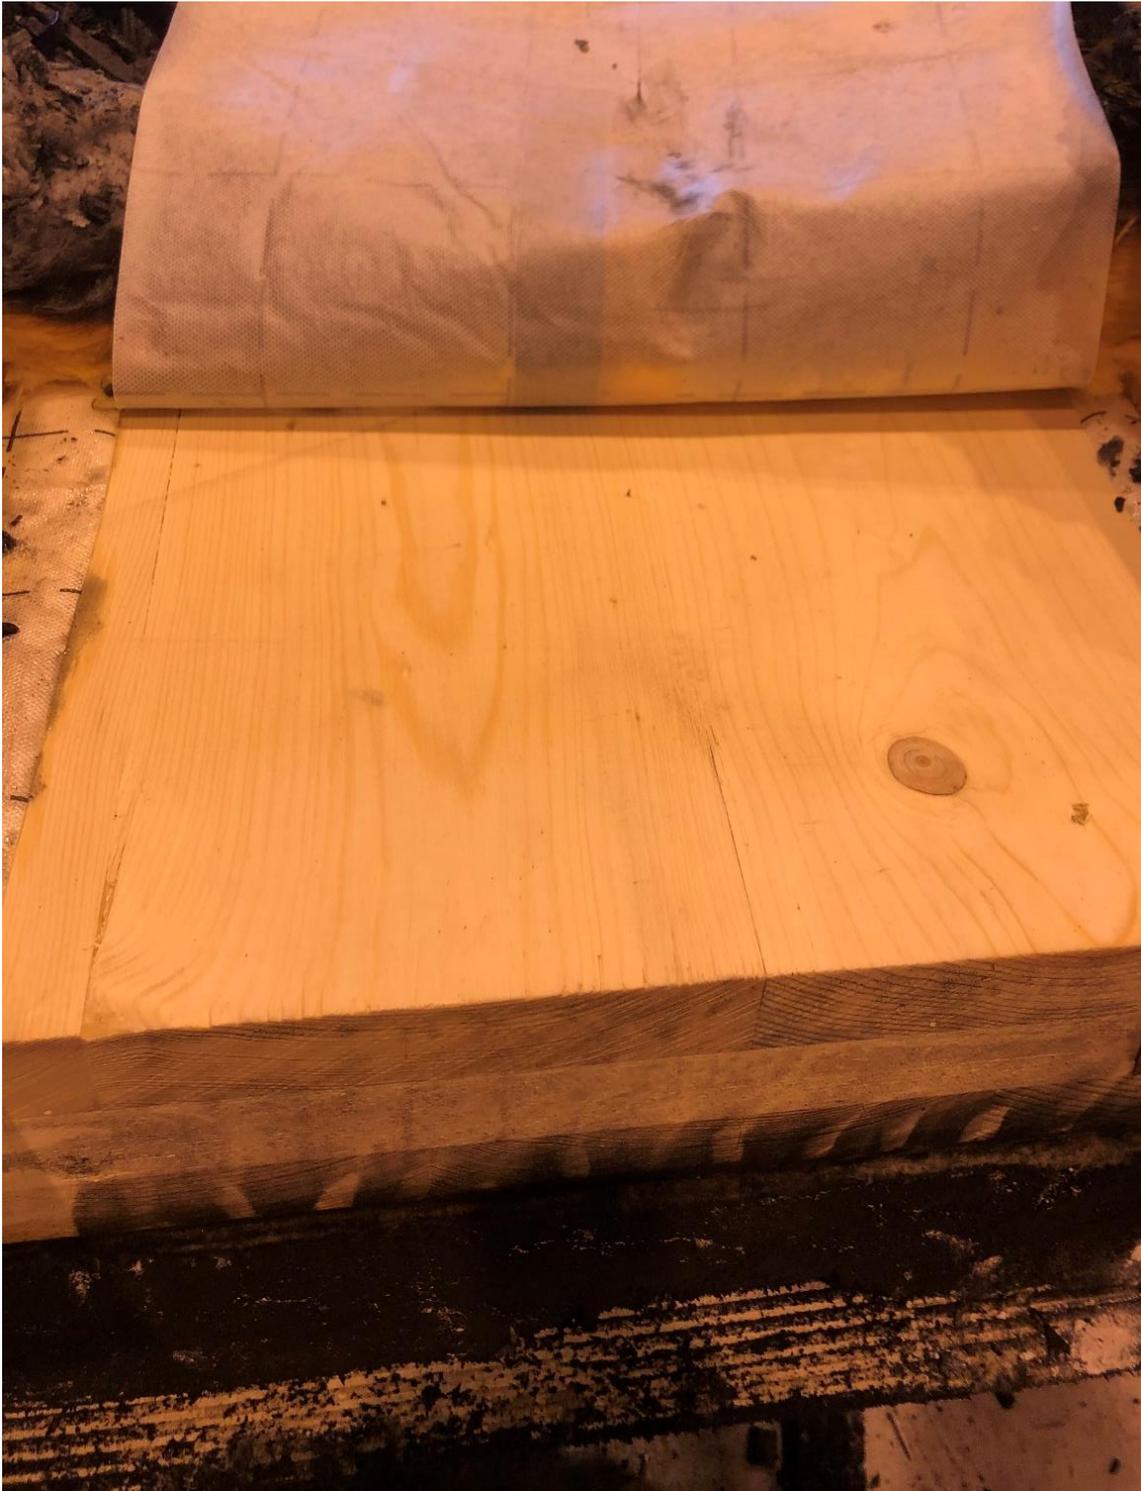
Figure 8: The surface of the CLT slab behind the exposed façade system after Test 1.

Figure 8 shows the surface of the CLT, after the test, on side of the fire exposure, at the location that was positioned right above the fire room during the test. Figure 9 shows the total surface of the CLT on the side of the fire exposure after the test. No coloring or charring of the CLT member was observed. The minor black areas visible in Figure 9 are smudges of char that fell from the facade system.

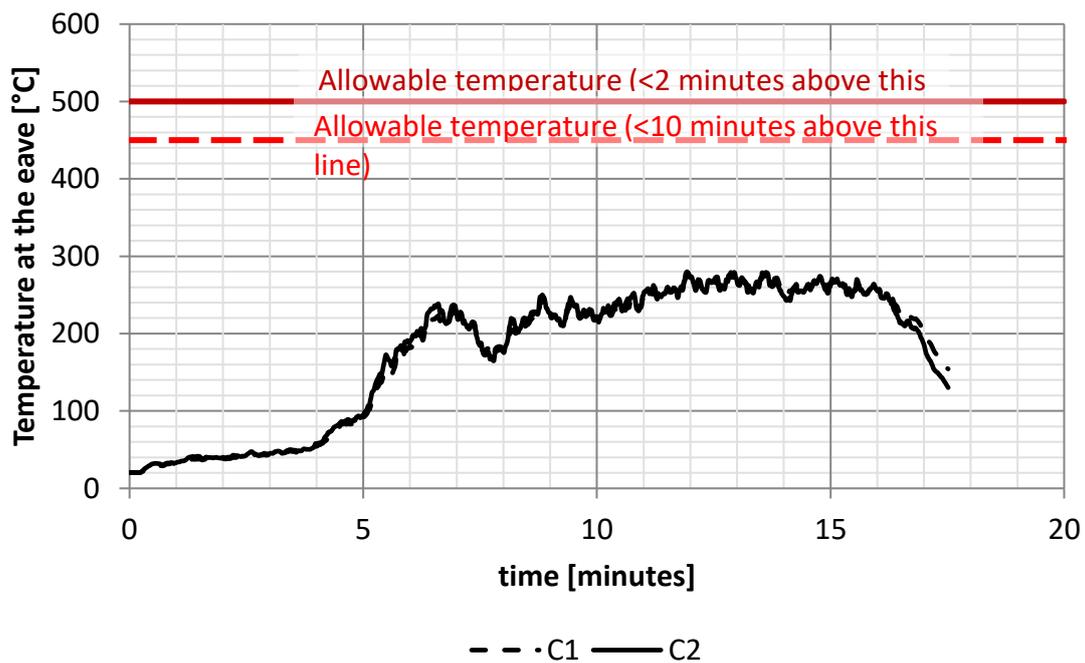
Figure 13: Temperatures at the eave during Test 2 together with the allowable temperatures at that location

- The maximum temperature measured below the eave was 280 °C, which is well under the allowable temperature of 500 °C during a continuous period longer than 2 minutes or 450 °C during a continuous period longer than 10 minutes.

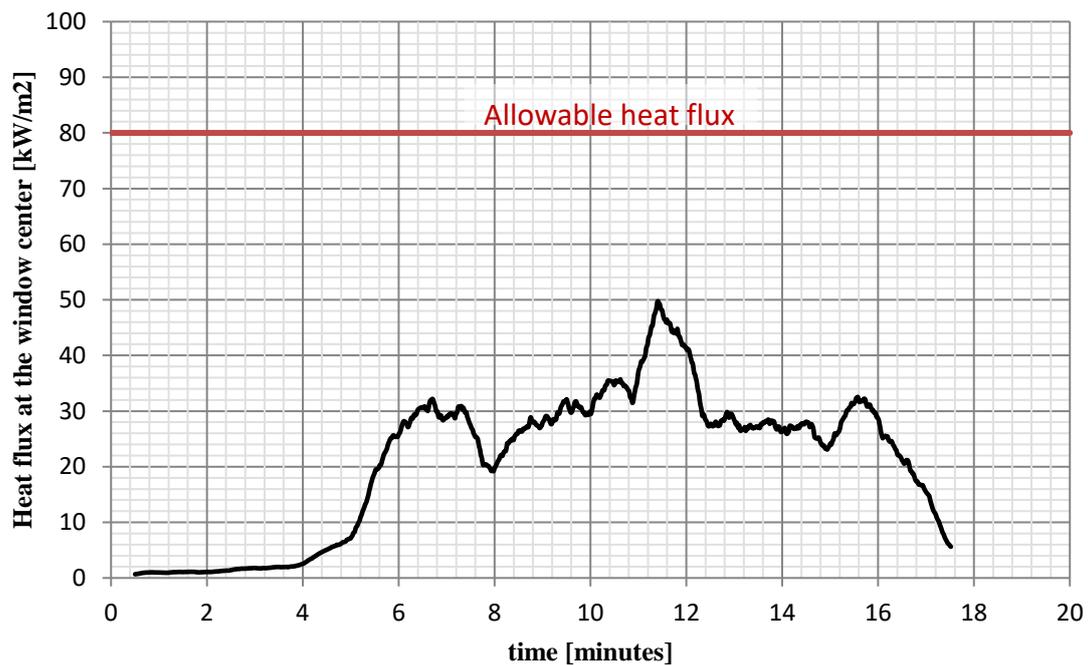
Figure 14: Heat flux at the window center on the first floor during Test 2 and the allowable heat flux

- The heat radiation towards the test specimen in the center of the fictitious window in the floor above the fire room did not exceed 80 kW/m² during the test. Maximum measured heat radiation was measured to 50 kW/m².

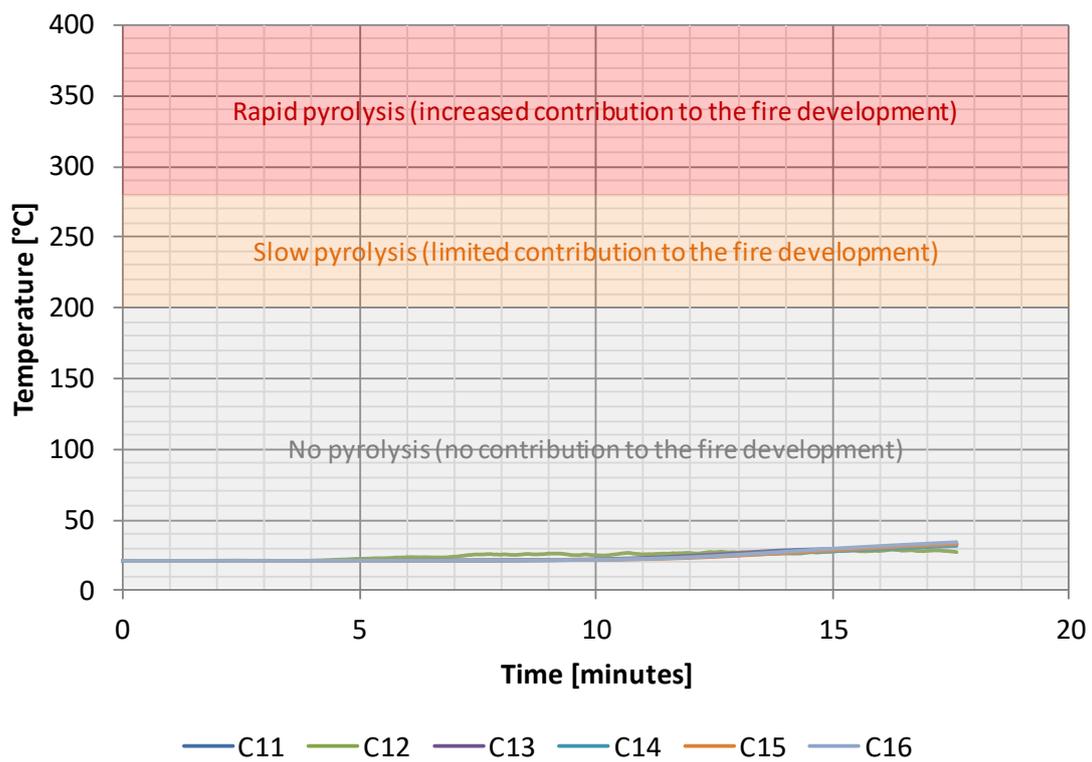
Figure 15: All temperatures measured at the surface of the particle board on the side of the fire exposure of Test 2 (locations shown in Figure 10)

Figure 15 shows the temperatures measured on the surface of the particle board on the side of the fire exposure, together with the temperature ranges indicating the particleboard’s contribution to the fire development. The maximum temperature measured on this surface was less than 35°C, which is well under the pyrolysis temperature.

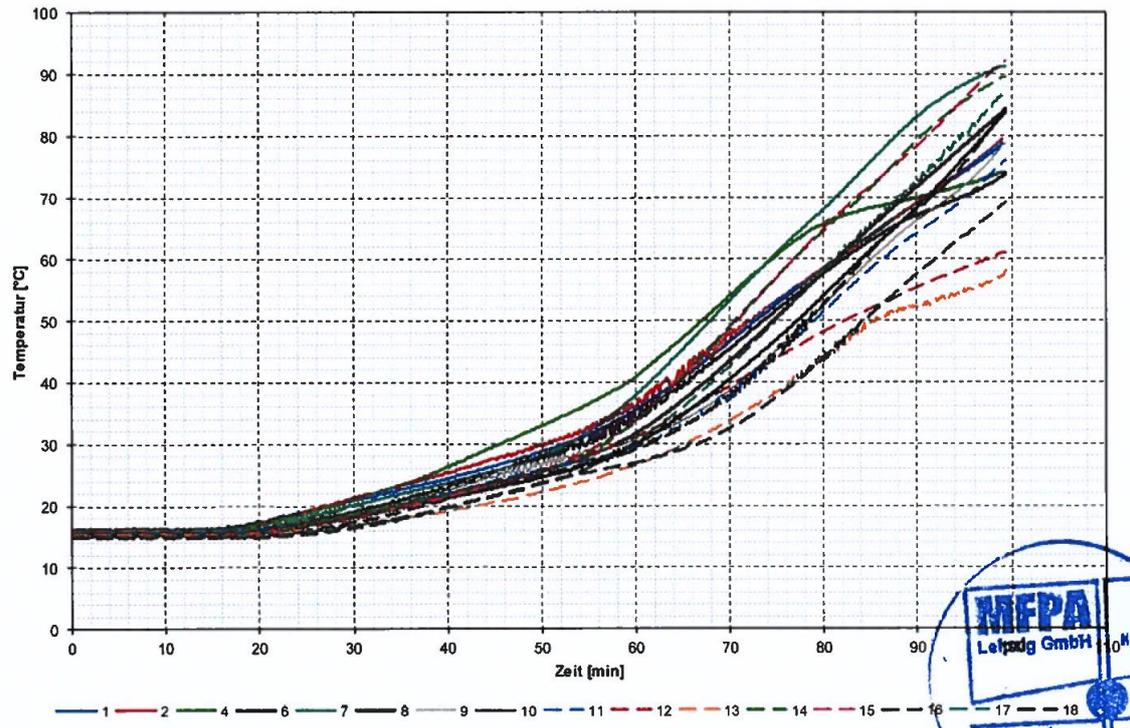
Figure 18: Temperatures at the interface between the CLT panel and the fire protection board.

The test setup passed all fire resistance criteria of EN 1363-1 2012 for the full duration (99 minutes) of the test. Temperatures measured at the interface of the CLT and the fire protective board are shown in Figure 18. The maximum temperature measured at the timber surface was 92°C , which is lower than the pyrolysis temperatures of $>200^{\circ}\text{C}$, discussed in Chapter 3.

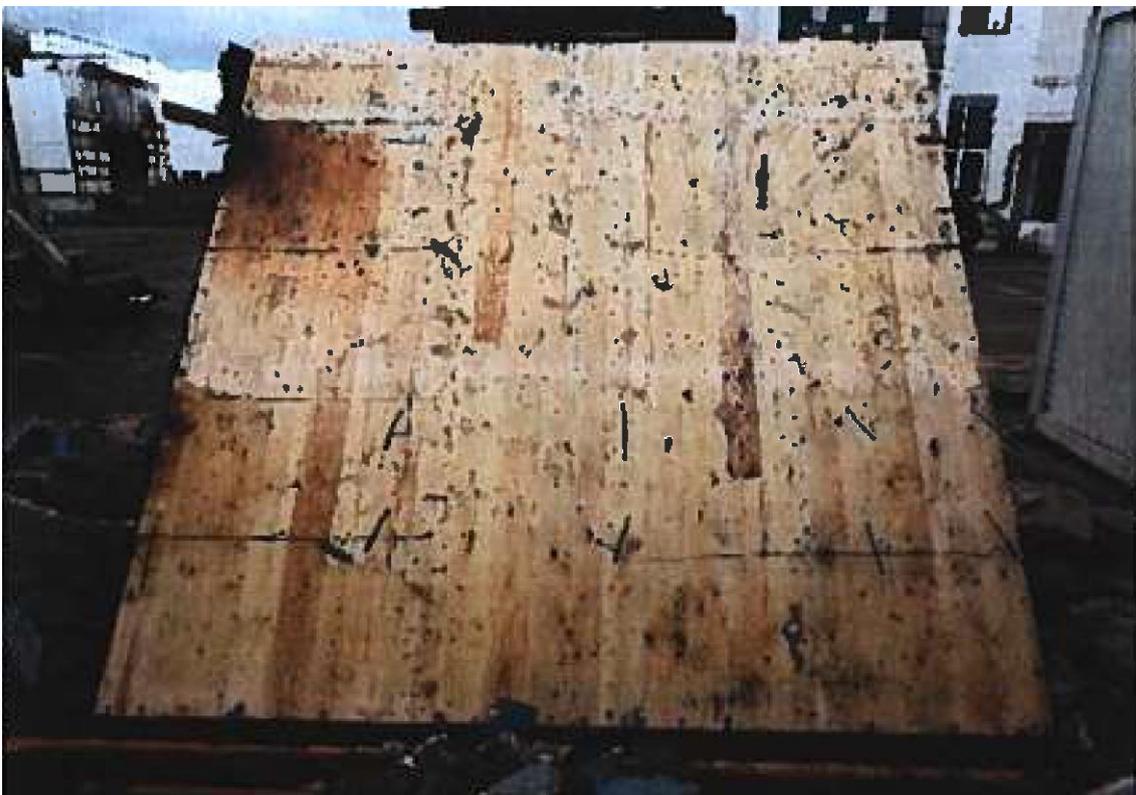
Figure 19: surface of the CLT panel on the side of the fire exposure, after the 99 minutes long fire resistance test.

The surface of the CLT panel on the side of the fire exposure, after the 99 minutes long fire resistance test, is shown in Figure 19. Aside from local coloring on the left side of the panel, the panel was largely undamaged. The total volume of charred material was minimal.
