Outdoor tests of timber beams and columns

Anna POUSETTE
Researcher
SP Technical Research
Institute of Sweden/
Wood Technology
Skellefteå, Sweden
anna.pousette@sp.se

Karin SANDBERG
Researcher
SP Technical Research
Institute of Sweden/
Wood Technology
Skellefteå, Sweden
karin.sandberg@sp.se

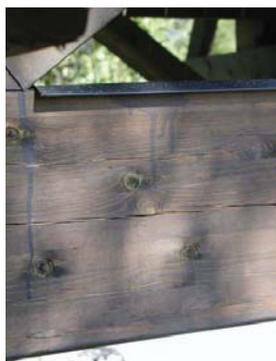
Figure 1. Fällfors Bridge

Inspections of timber bridges can detect cracks in timber parts. Some examples from inspections of bridges with cracked beams are shown in [4]. The Fällfors Bridge in Figure 1 is a pedestrian truss bridge of pressure treated pine that is surface treated with dark wood oil with a hint of pine tar. After two years there are cracks on the top and bottom chord. The Engarn Bridge in Figure 2 is a pedestrian beam bridge of pressure-treated pine painted with oil paint and façade paint, and after seven years has some minor cracks and delamination on the outer sides of the beams.

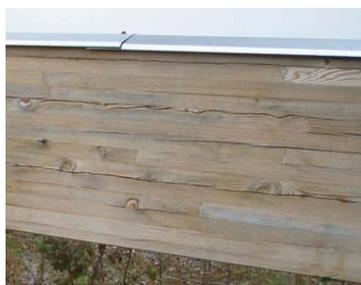
Figure 9. Inspection 2010 of beams treated with wood oil

- the pressure treated beams treated with wood oil has significant cracking on both southern and northern side, see figure 9,
- there are some significant cracks in the painted beams, especially on the south side of the red spruce beams, see figure 10,
- there are some beams with few cracks, especially red and white pressure treated beams,
- the red colour had faded somewhat.

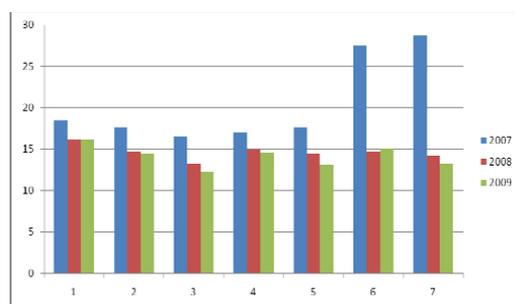
Figure 11. Moisture content of one beam B3 measured at middle, positions 1-7 according to figure 6.

Generally the beams (B) had quite high moisture contents (mean 25.8%) at start of the test period and after three years exposure they had dried (mean 18.9%). Figures 11 and 12 show the moisture content (MC) in one beam during three years.

Moisture content readings at the start showed some high moisture contents, over 20% and up to 60%, suggesting that water got into the beams at the pins probably because some boxes were not directly sealed. Some of these have dried out after the first year, but some are still wet after some years.
