Lennart Carlsson

CYCLIC FATIGUE OF  
HOT-ISOSTATIC-PRESSED  
SILICON NITRIDE

SP Report 1989:43  
Materials and Mechanics  
Borås 1989

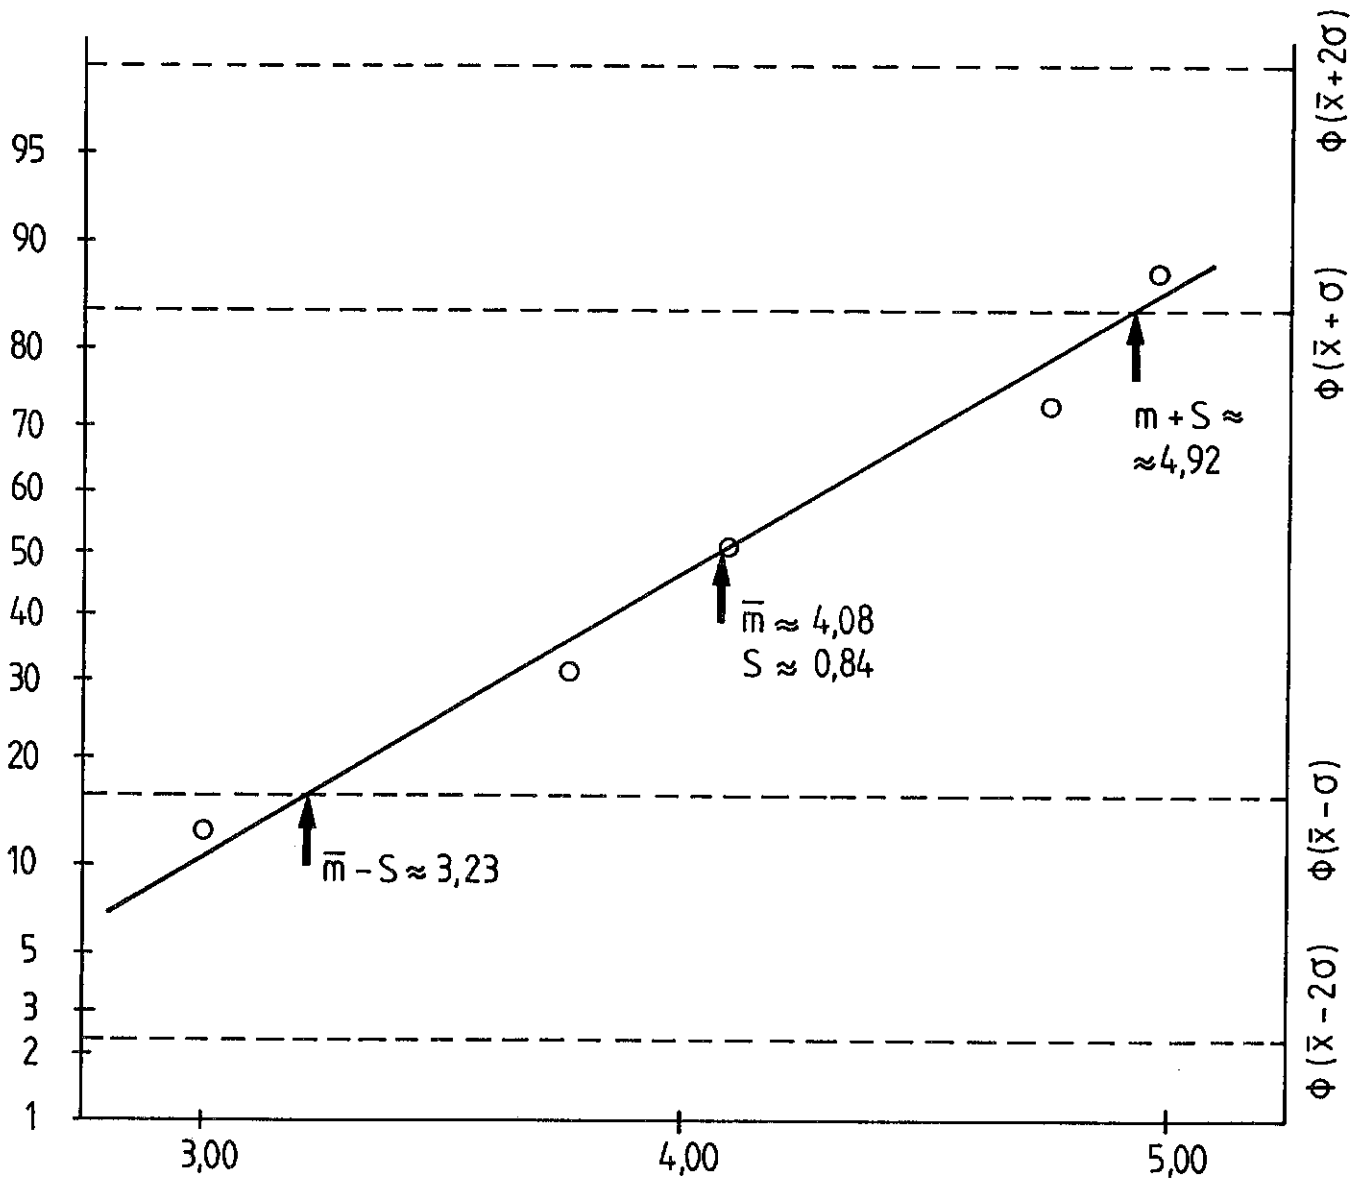
ANNEX

Grafical evaluation of fatigue data for determination of mean value and standard deviation for the three stress levels.

$\sigma_{\max} = 464 \text{ MPa}$

$\sigma_{\max} = 548 \text{ MPa}$

$\sigma_{\max} = 625 \text{ MPa}$

A graphical evaluation of the data from the three stress levels are presented in fig. 1, 2 and 3 in ANNEX. A fit to a log - normal distribution is good even if the standard deviation is high for the highest stress level.
