Collection of Façade Fire Tests Including Timber Structures

Daniel Brandon

RISE Rapport 2020:50

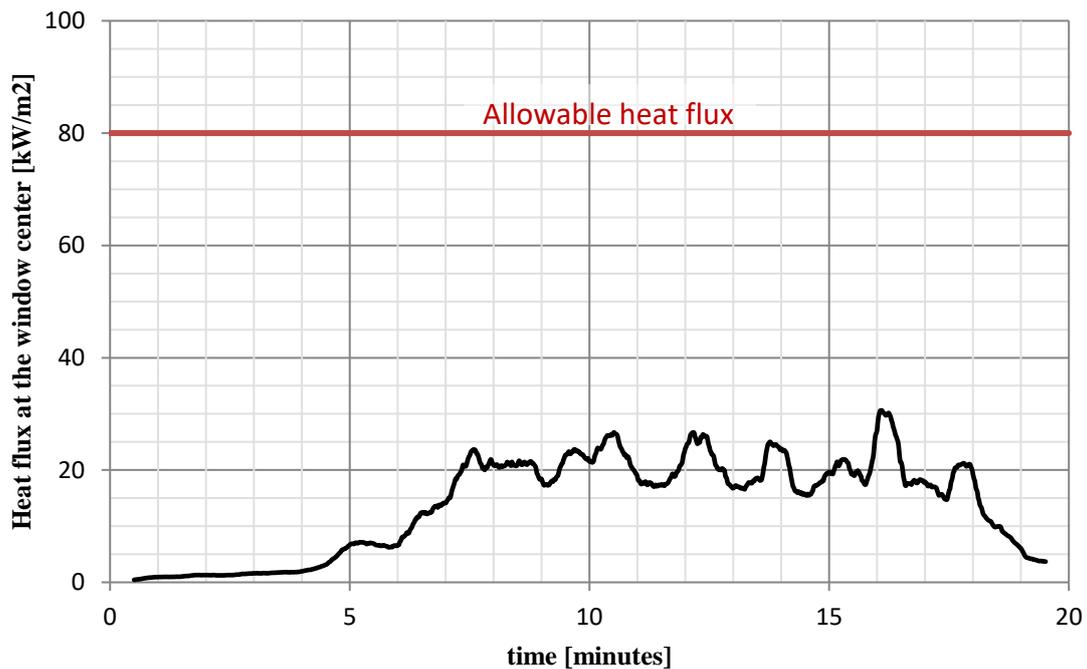
Figure 6: Heat flux at the window center on the first floor during Test 1 and the allowable heat flux

The by SP Fire 105 (1994) required measurements of the temperature under the eave and the radiation towards the window on the first floor and the radiation towards the center of the first window are shown in Figure 5 and Figure 6, respectively. The allowable temperature and allowable heat flux are indicated in the figures. The tested façade fulfilled the requirements of the Swedish building regulations listed in the beginning of this chapter and the measurements remained well within the allowable range:

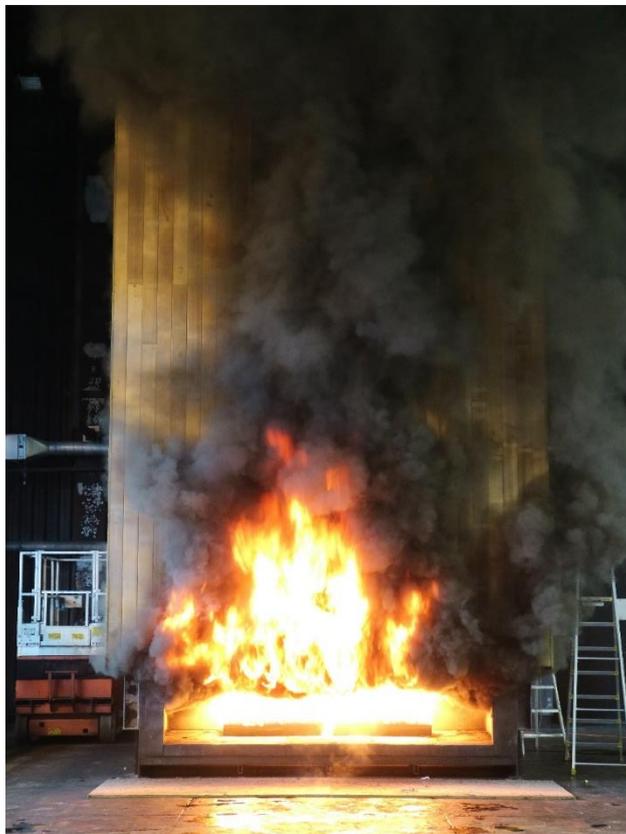
Figure 12: Photo during Test 2.

- During the test, there was a drop-off from the test specimen. The drop-off consisted of charred pieces of facade panel. The pieces had a separate maximum size of approx. 15 x 15 cm and did not burn on the floor in front of the test specimen. The total weight was estimated to less than 5 kg in total.
