# Fire Safety of CLT Buildings with Exposed Wooden Surfaces

Daniel Brandon  
RISE, Fire Research  
Stockholm, Sweden

Alar Just  
RISE, Fire Research  
Stockholm, Sweden

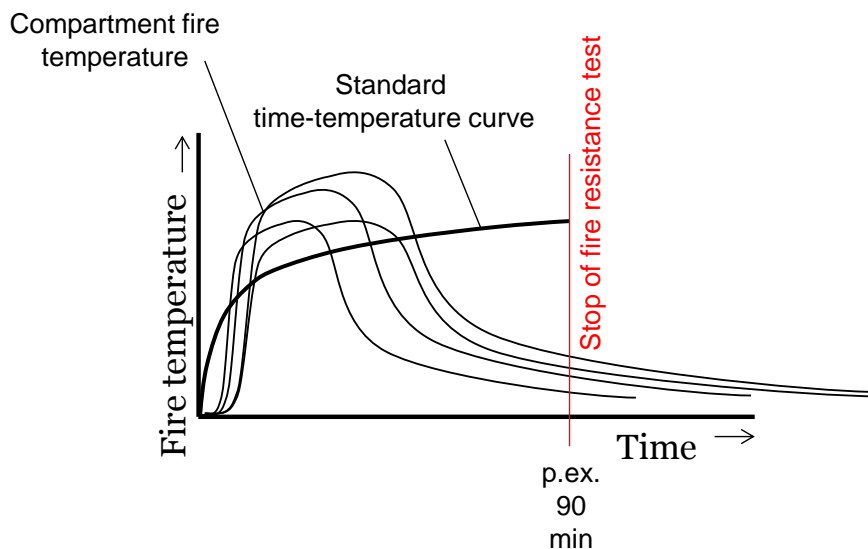
Figure 1: temperatures of a standard fire resistance test versus temperatures of compartment fires (schematic)

Structural fire resistance requirements indicate a number of minutes a structure should withstand temperatures of a standard fire resistance test without collapse. In a standard fire resistance test, a CLT specimen has to be exposed to temperatures described by a standard time-temperature curve as shown in Figure 1. The required duration of a fire resistance test is dependent on regulatory requirements (i.e. the required fire resistance time). In a (real) compartment fire, the temperatures and the duration of a fire are mainly dependent on the amount of fuel available, ventilation conditions of the compartment, and thermal properties of the compartment linings. Once the combustible content (such as furniture) of a compartment starts to burn out in a compartment fire, the decay phase of the fire starts.

A structural fire resistance requirement of, for example, 90 minutes does not indicate that the building would collapse after 90 minutes in a real fire. It is possible that fulfillment of the fire resistance requirement avoids collapse for the entire duration of a natural fire even if fire service intervention or effective sprinkler activation is absent. Whether collapse is prevented by using fire resistance requirements, is dependent on the temperatures and duration of the compartment fire and the required time of fire resistance. However, it can be stated that collapse can be avoided if continuous compartment fires are avoided and if fire resistance requirements are conservative enough (i.e. if the red line in Figure 1 is located far enough to the right hand side).

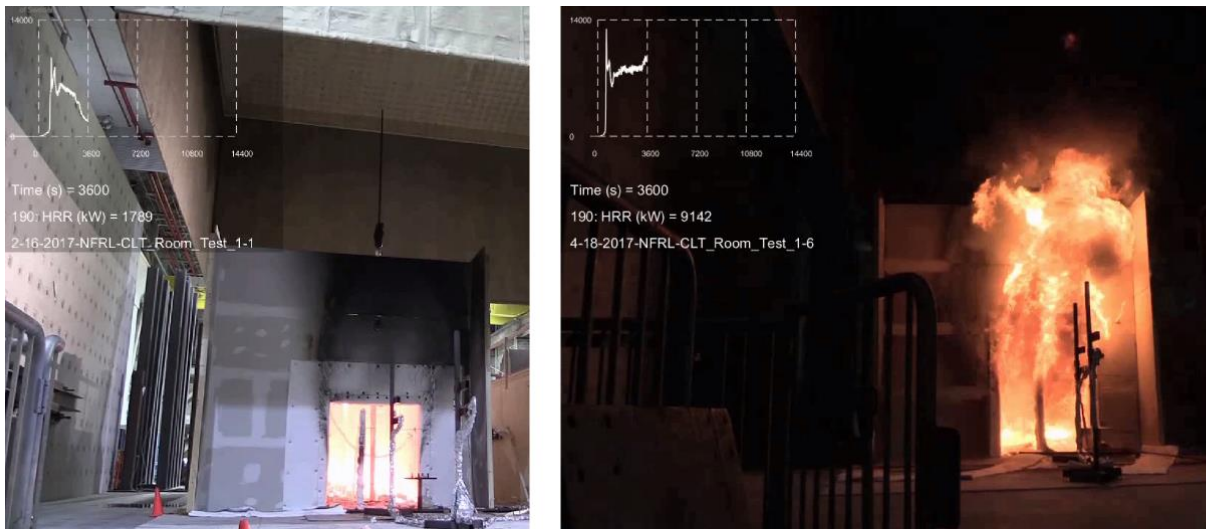
Figure 3: Fully encapsulated compartment (left) and compartment with an exposed CLT wall and ceiling (right) 1 hour after ignition (Frame of a video by NIST, USA).
