RoBound – Ro-ro space boundary fire protection – Literature Study

Anna Olofsson, Franz Evegren, Pierrick Mindykowski

RISE Report 2021:68

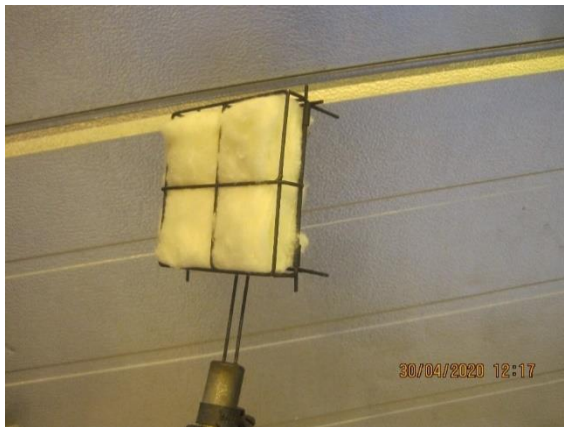
Figure 1. Cotton-wool pad used for testing ignition (flaming or glowing) on the unexposed side. Size: 100*100*20 mm. 3-4 g of cotton

§8.4.3.1: Tests with the cotton-wool pad are used to indicate whether cracks and openings in the test specimen are such that they could lead to the passage of hot gases sufficient to cause ignition of combustible materials.

To give the reader an idea of the cotton-wool pad and the gap gauges used in the FTP tests pictures are added showing such equipment from RISE's Fire laboratory facilities, where accredited FTP Code testing is carried out in Borås, Sweden.

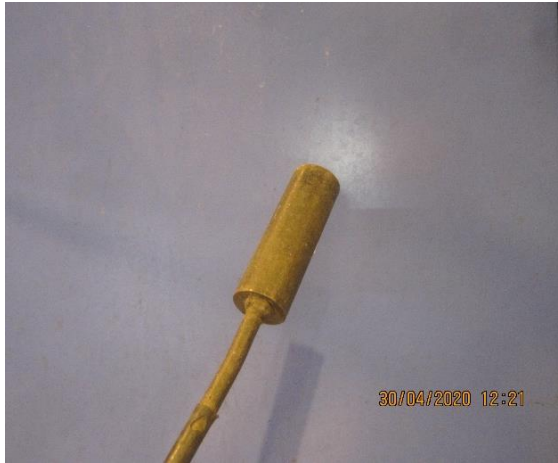
Figure 2. Gap gauges for measuring openings in tested specimen. 25 mm in diameter

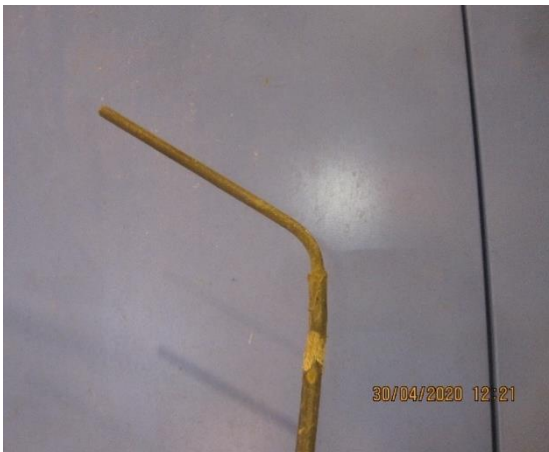
Figure 3. Gap gauges for measuring cracks in tested specimen. 6 mm in diameter to move 150 mm in different directions of the crack.

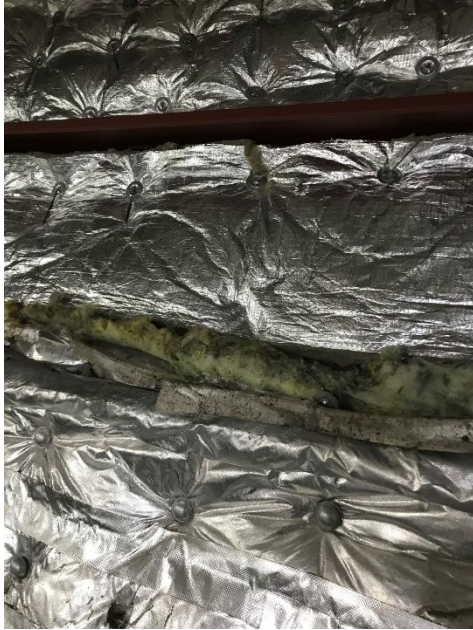
Figure 4 Example of damaged fire insulation

- Fire insulation in ro-ro spaces can be damaged by loading of trailers or during maintenance work. There can also be water damage (testing of drenchers, cleaning or by rain) and general wear and tear. Damaged insulation happens but not too often so it is not experienced as a problem for the crew.

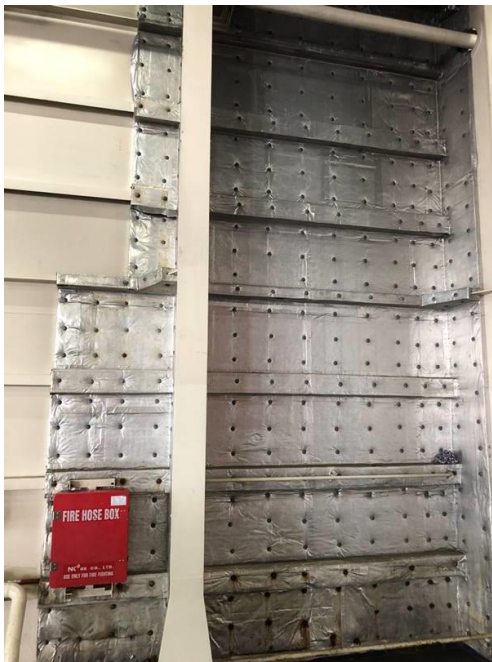
Figure 5 Example of undamaged insulation

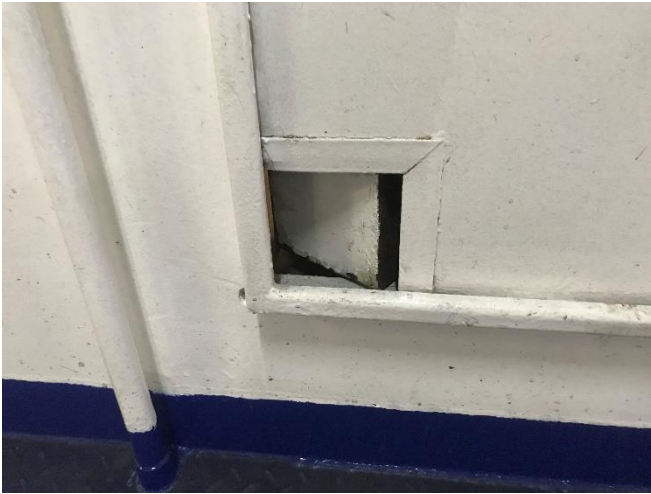
Figure 6 Example of “cat hole” in hinged door

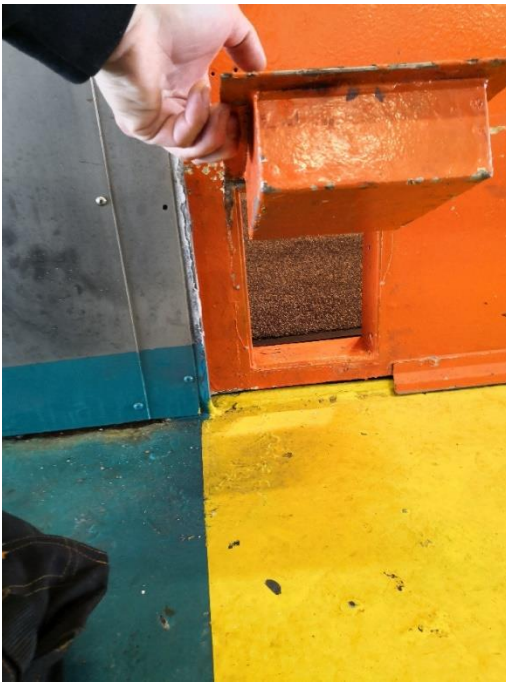
Figure 7 Example of “cat hole” in sliding door
