2019-010

# Examination of laser treated aluminium

Anton Bjurenstedtare

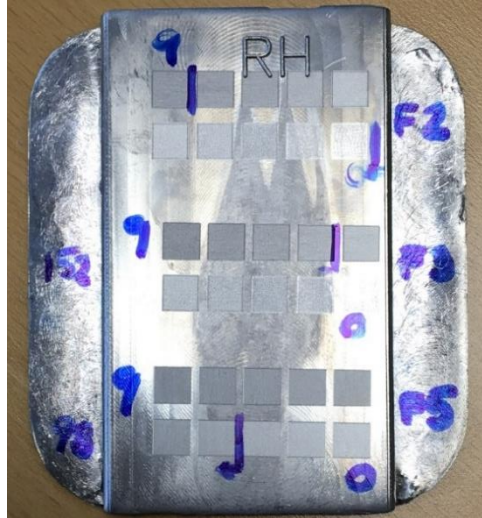
Figure 1. A HPDC test plate with various laser treatments. The backside of this palate was not treated by the laser. The size of the plate is about 60x70mm.

Figure 1 show a HPDC test plate with various laser treatments. Three different sets of treatments were performed and named F2, F3, and F5.

F2: is from low to high pulse frequency.

På **Ljunghälls gjutna Al-detaljer** (Marie och Andreas prover) så har jag först gjort en provplatta med olika parametrar där ni kan se en större variation bland effekter som kan åstadkommas. F2 visar en bredd från hög till låg pulsfrekvens. F3 visar på 10 parametrar av den halvan av de snällare parametrarna. F5 visar istället på 10 parametrar av den halvan av de tuffare parametrarna hos F2. Den sida som är markerad 0 utgår från den mildaste behandlingen och 9 motsvarar den tuffare behandlingen och så går det stegvis upp mellan dem. 4 olika nivåer har valts ut till större ytor det är 200kHz som finns vid 0 på F2, 50kHz som finns vid 9 på F2, 152kHz som finns är markerad på F3 och 98kHz som är markerad på F5.

The HPDC sample seen in Figure 1 was examined in the SEM. Six laser treated squares were examined. The squares chosen were numbered 1 to 6 and the positions of the squares are shown in Figure 5.

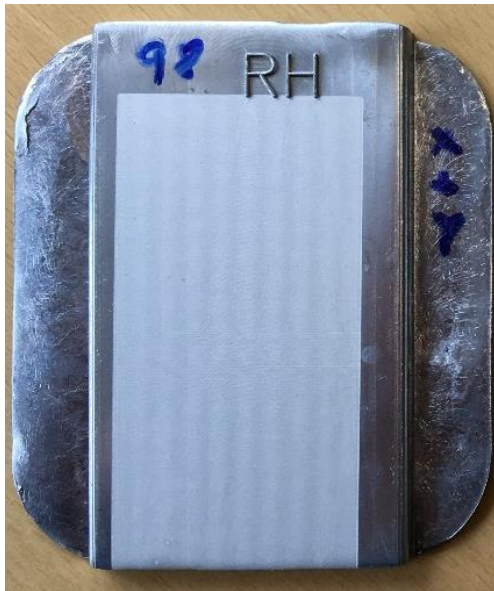
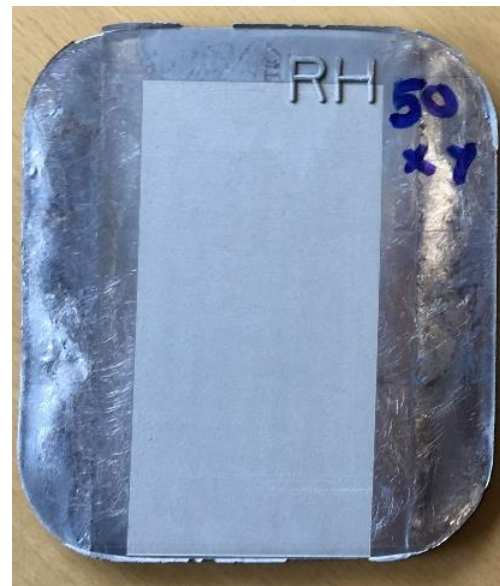
Figure 2. Test plate 2. Front side treated with 98kHz and backside treated with 50kHz.

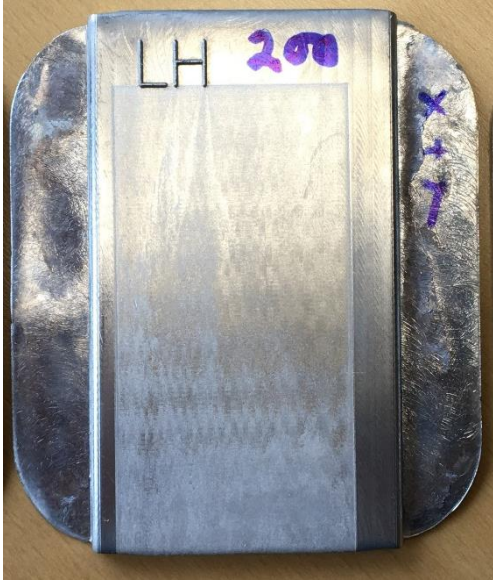
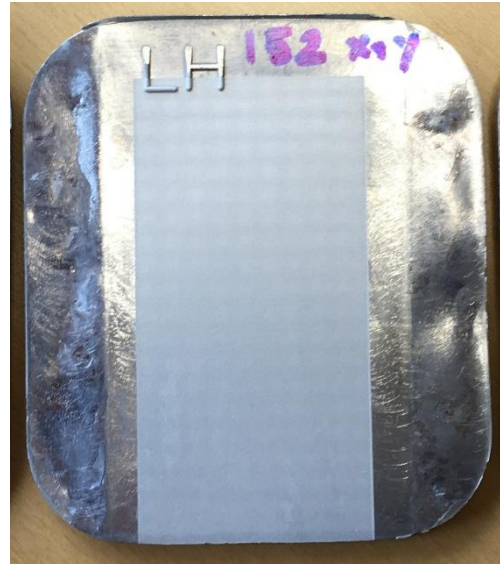
Figure 3. Test plate 3. Front side treated with 200kHz and backside treated with 152kHz.

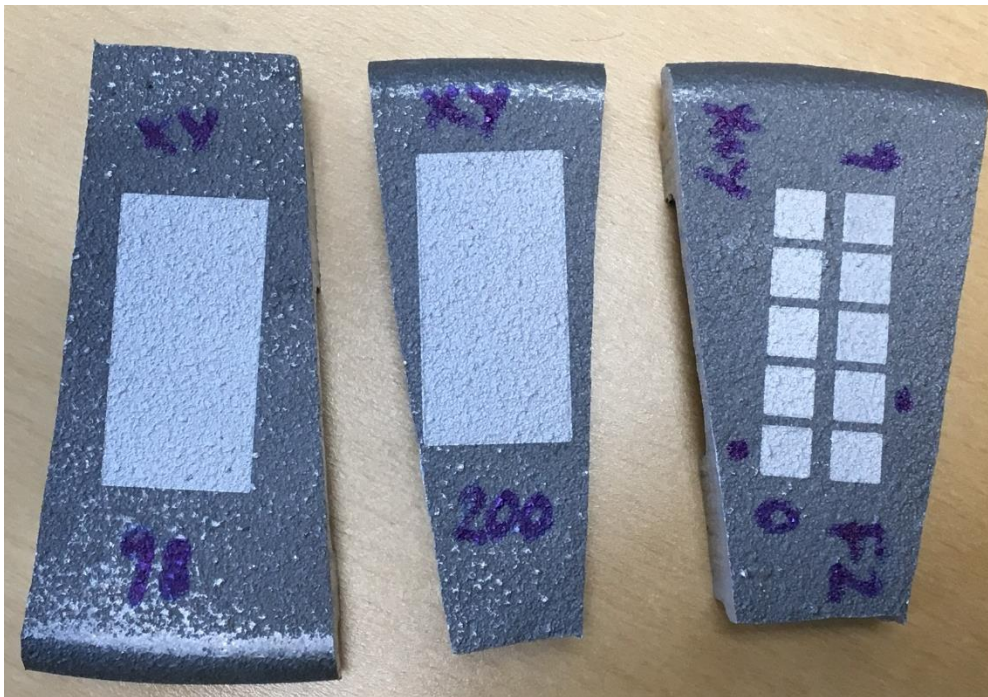
Figure 4. Test specimens cut from a sand cast component. The size of the plates are about 30x65mm.

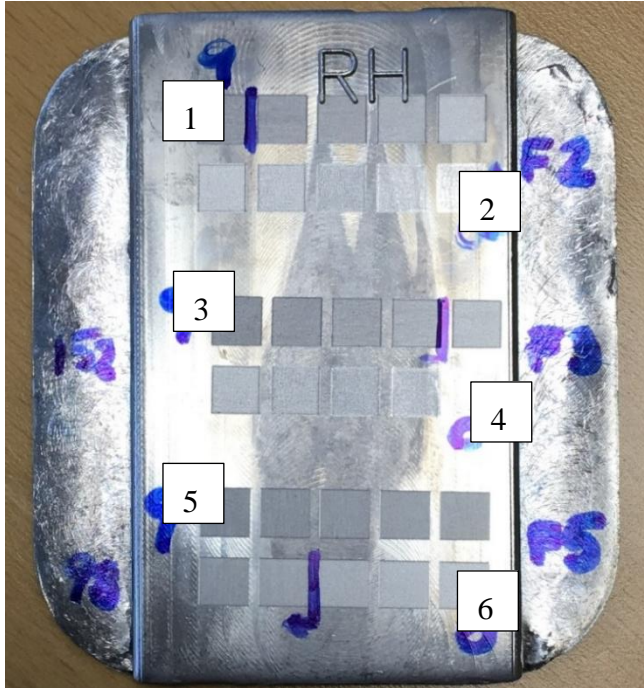
*Figure 5. Marking of areas examined in the SEM.*

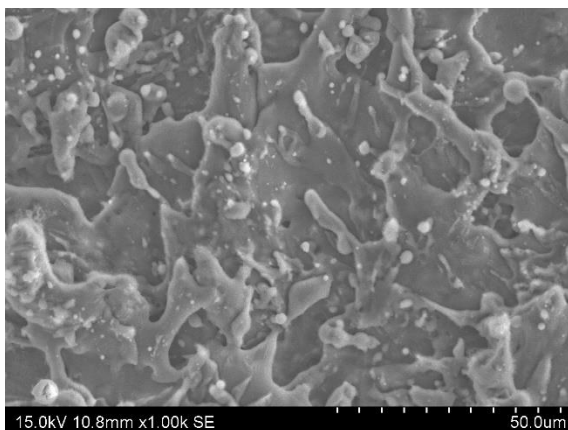
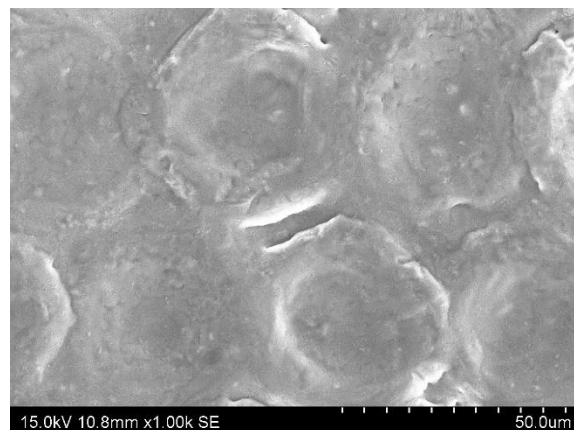
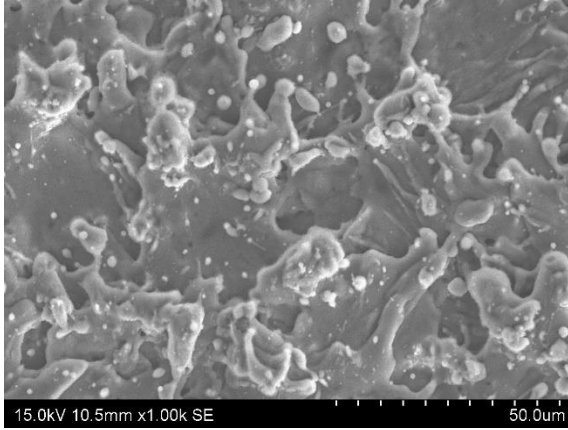
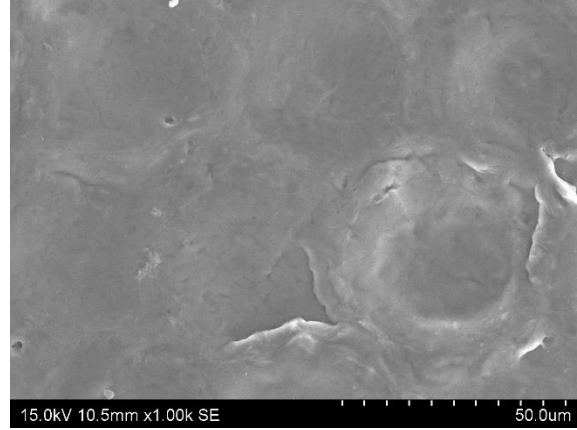
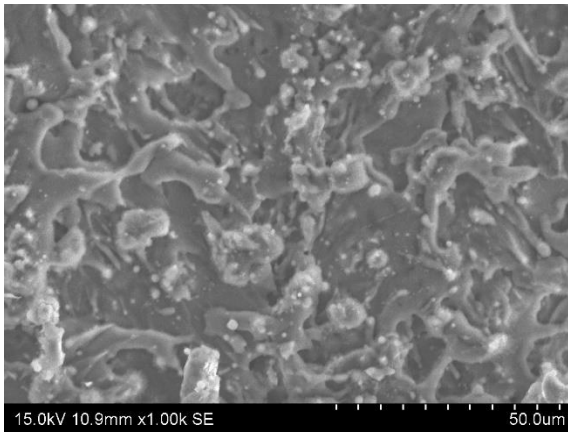
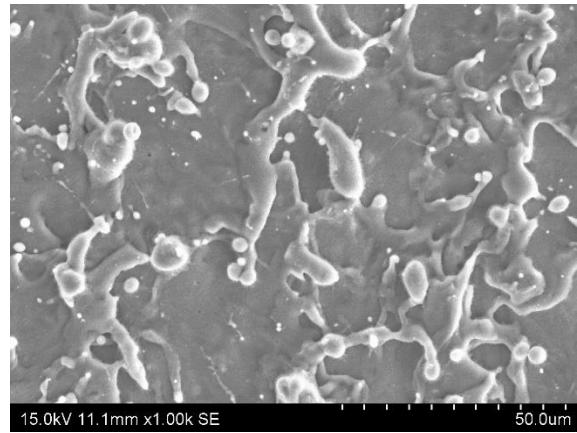
Figure 6. Images of six examined areas. (a) Area 1, (b) Area 2, (c) Area 3, (d) Area 4, (e) Area 5, and (f) Area 6. Original magnification 1000x.

The laser treatments of the surfaces have influenced the surface appearance and the microstructure. The effect on the surface appearance is shown in Figure 6. Examination of cross sections revealed a 3-10 µm thick layer of, what appears to be aluminium (based on ocular examination), has formed. The examination in the SEM-EDS gave no answer on the composition of the surface layer formed.

Images from the SEM examination are shown in Figure 6.

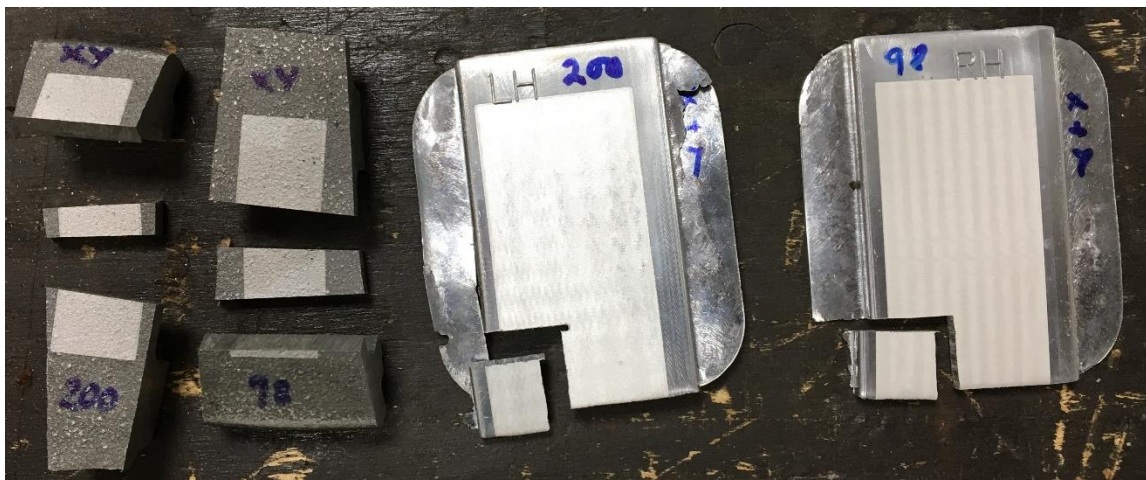
Figure 7. Cuts made before mounting and preparation for examination in light optical microscope.

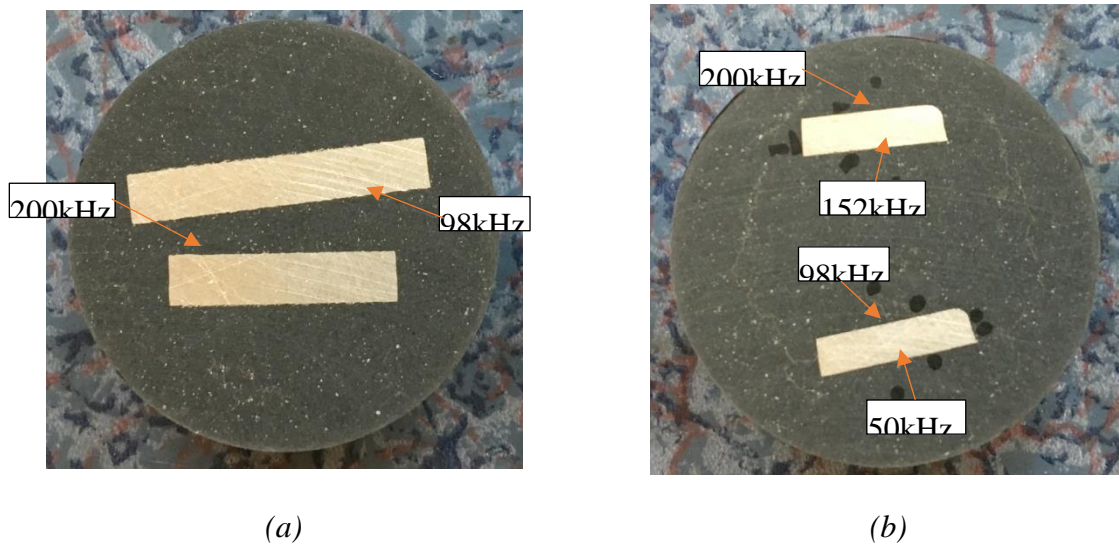
Figure 8. Images of the mounted samples with the pulse frequency of the laser. (a) sand cast component, the long sample was treated 98kHz (sand 98) and the shorter specimen

was treated with 200kHz (sand 200). (b) The HPDC, the side with rounded corner of the longer sample (HPDC 95 – 50) was treated with 98kHz and its opposite side was treated with 50kHz. The side with rounded corner of the shorter sample (HPDC 200 – 152) was treated with 200kHz and its opposite side was treated with 152kHz.

Sample ID	Note
sand 98	Sand cast sample treated with 98kHz laser.
sand 200	Sand cast sample treated with 200kHz laser.
HPDC 98 – 50	HPDC sample treated with 98 and 50 kHz laser.
HPDC 200 - 152	HPDC sample treated with 200 and 152 kHz laser.

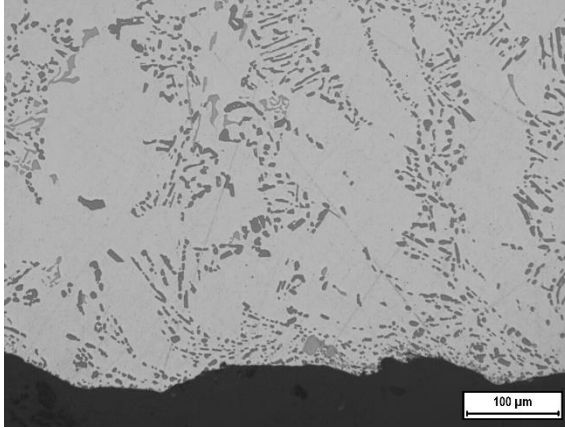
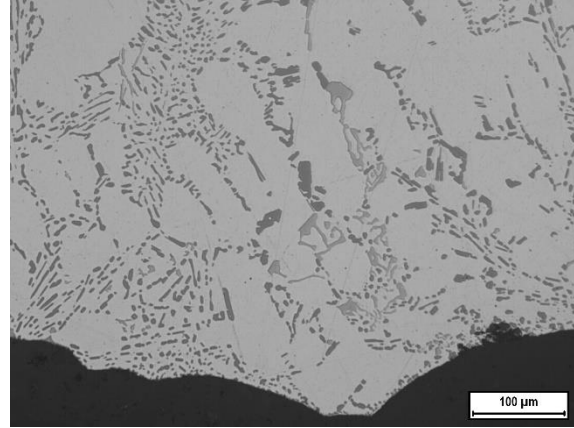
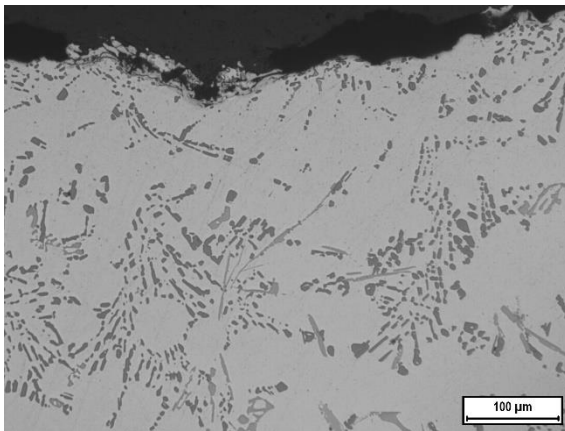
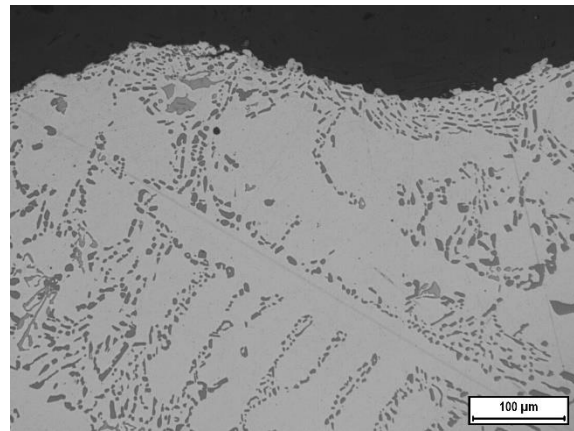
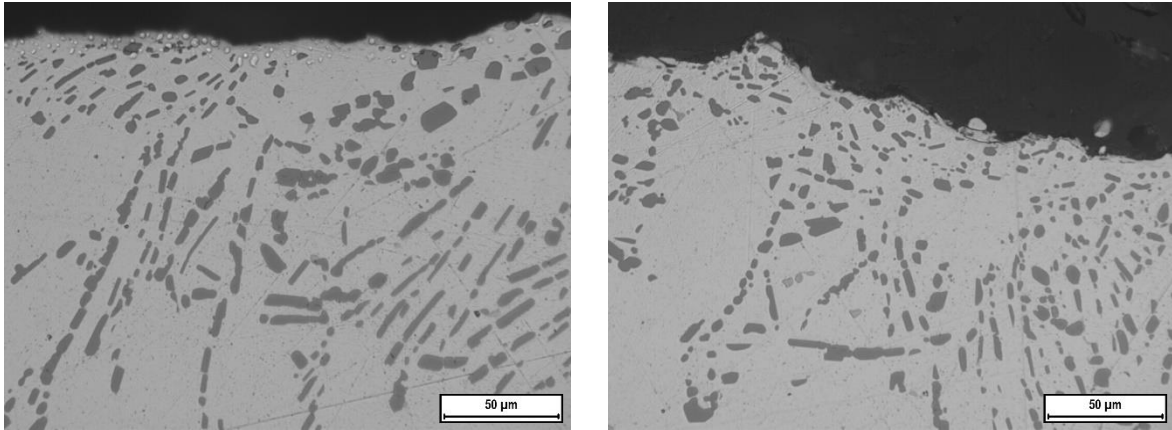
Figure 9. Micrographs of, in the left column, sand 98 and, in the right column, sand 200. (a) and (b) show untreated surfaces. (c) – (f) show treated surfaces at two different magnifications.

Only small differences related to the appearance of the treated surface could be observed. The laser treated surface was seen to be more jagged than the untreated surface. No significant differences in the microstructure could be observed between the untreated and the treated surfaces. Furthermore, no differences could be observed between the 98kHz and the 200kHz sample.

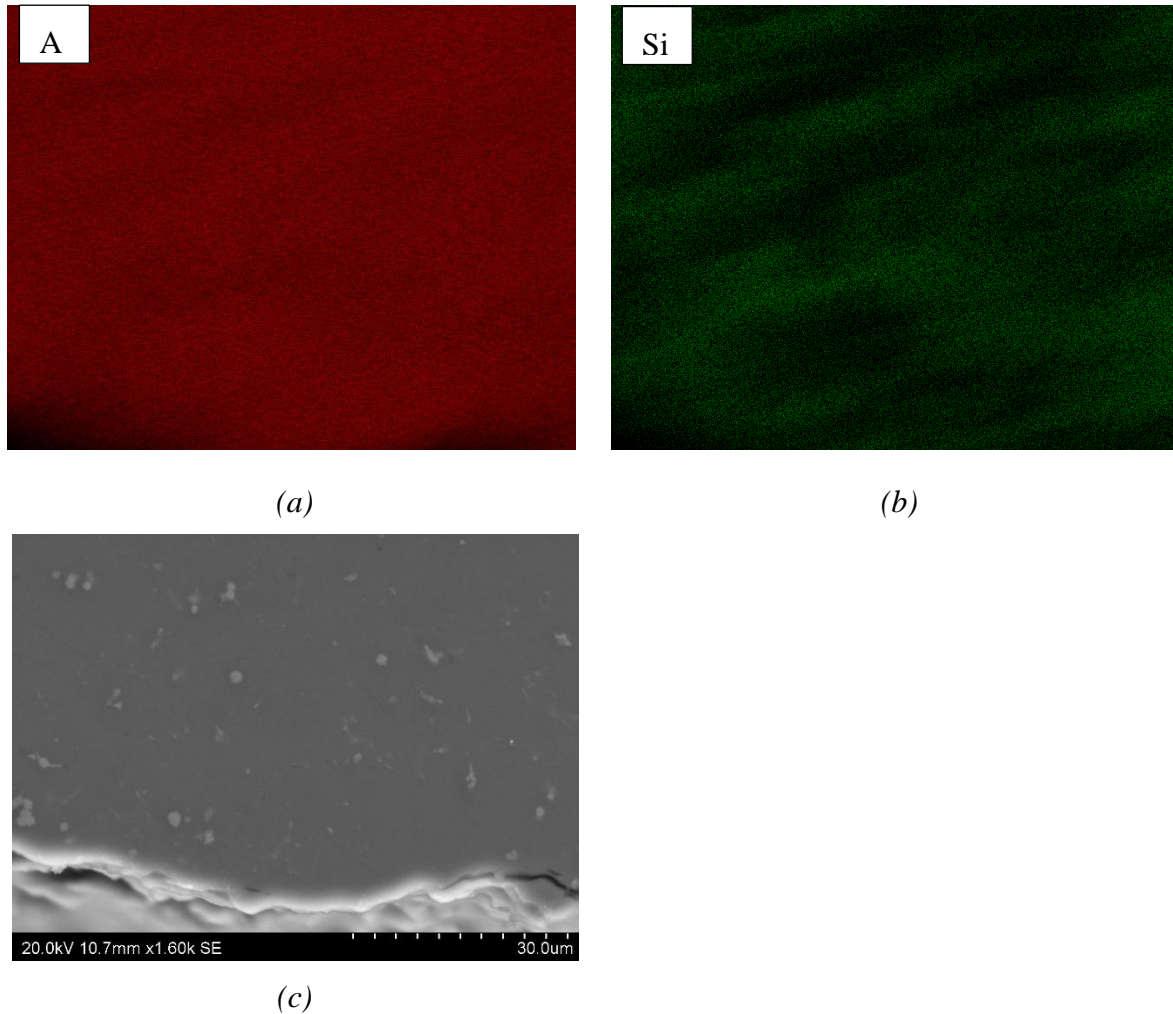
*Figure 11. SEM-EDS examination of the surface treated with 50kHz. (a) The red area shows the distribution of Al. (b) The green colour shows the distribution of Si. (c) secondary electron image of the area analysed.*

The HPDC sample treated with 50kHz and 98kHz was examined in the SEM. Both sides were analysed. Figure 11 and Figure 12 below show that there were no observations of deviating chemical composition towards the surfaces.

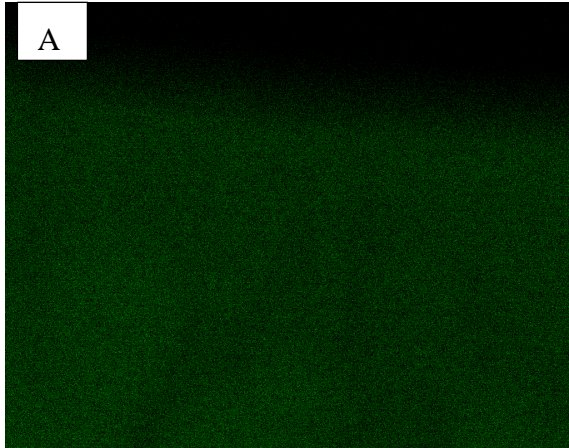
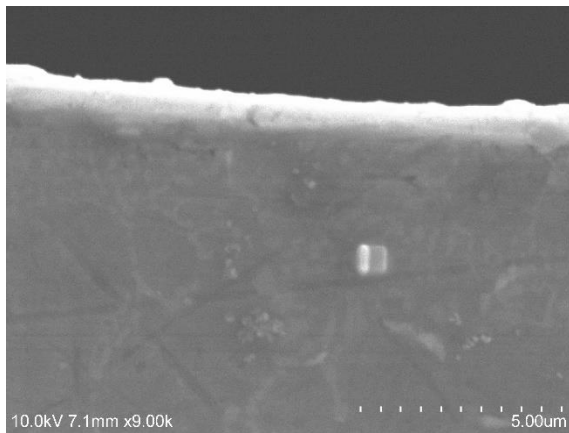
*Figure 12. SEM-EDS examination of the surface treated with 98kHz. (a) The green area shows the distribution of Al. (b) The blue colour shows the distribution of Si. (c) secondary electron image of the area analysed.*
