Fire Safety in Buses

WP1 report: Bus and coach fires in Sweden and Norway

**SP Swedish National Testing and
Research Institute, Fire Technology**
SP Report 2006:26

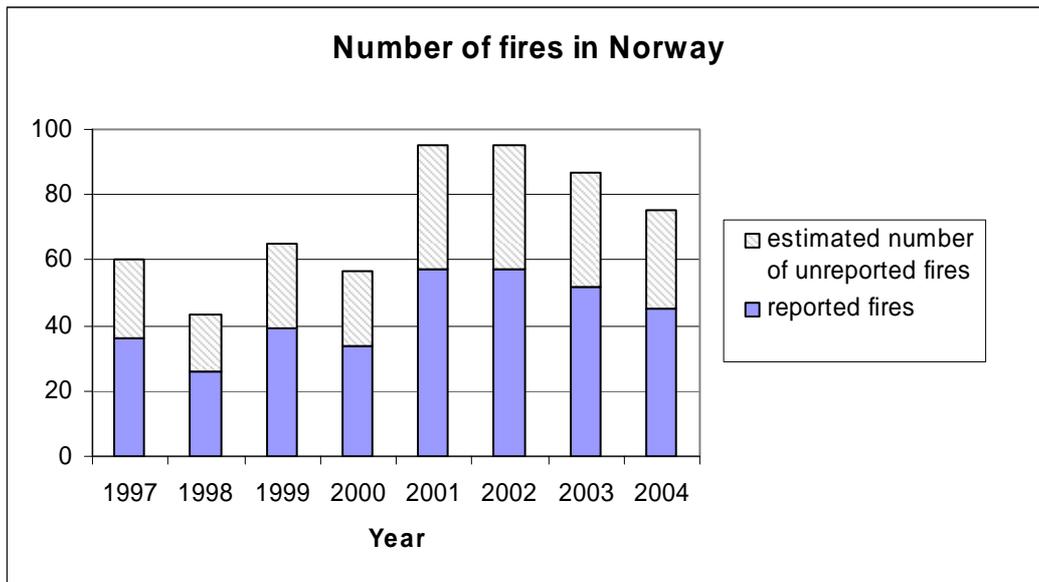
Figure 1 shows the number of such fires in Norway between 1997 and 2004. The shaded parts of the columns show the number of fires estimated to have occurred, but not shown in the statistics. Data for the period 1997-2000 has been taken from SINTEF's report¹.

Figure 1. The number of bus or coach fires in Norway, 1997-2004.

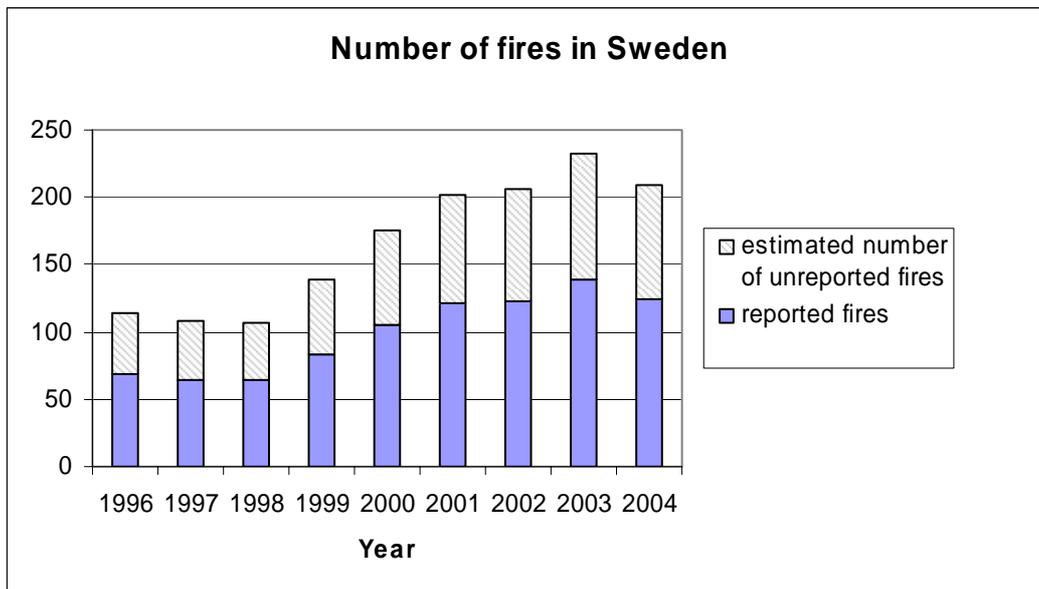
Figure 2 shows the number of reported bus or coach fires in Sweden over the period 1996–2004. The shaded parts of the columns show the number of fires estimated to have occurred, but not shown in the statistics.

Figure 2. The number of bus or coach fires in Sweden, 1996-2004.

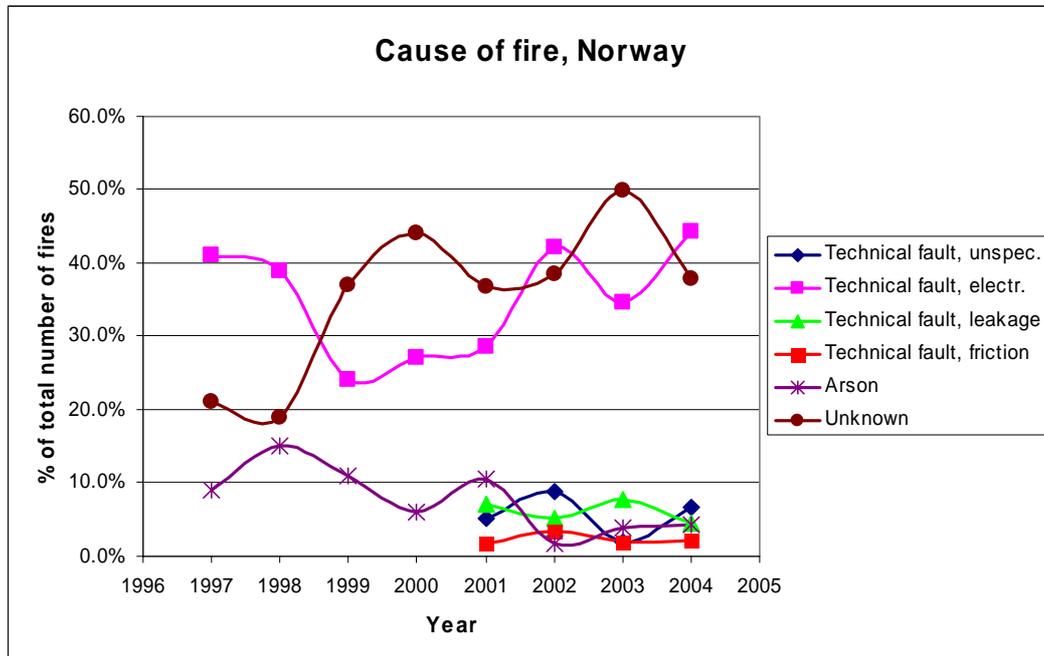
Figure 3 shows these causes plotted on a year-by-year basis, while Figure 4 shows the types of fires, expressed as a five-year average.

Data is available for the Electrical Faults, Arson and Unknown categories from the SINTEF Report¹ for 1997-2000, and has been included in Figure 3 in order to reveal any trends. The cause of some of these fires is uncertain, and has therefore not been included in the figure.

Figure 3. The causes of fires in Norwegian buses or coaches between 1997 and 2004, shown as a proportion of the total number of reported fires. Data from 1997-2000 has been taken from the SINTEF report¹.

Figure 3 and Figure 4 show the reported causes of bus or coach fires in Norway, broken down into six different categories:

- Technical fault (unspecified, but not arson).
- Technical fault, electrical (the fire has started in the vehicle's electrical system).
- Technical fault, leakage (the fire has started as the result of leakage of a flammable liquid, ignited by [for example] coming into contact with the hot exhaust system).
- Technical fault, friction (the fire has started as a result of frictional heating, usually in the wheel bearings or braking systems).
- Arson.
- Unknown.

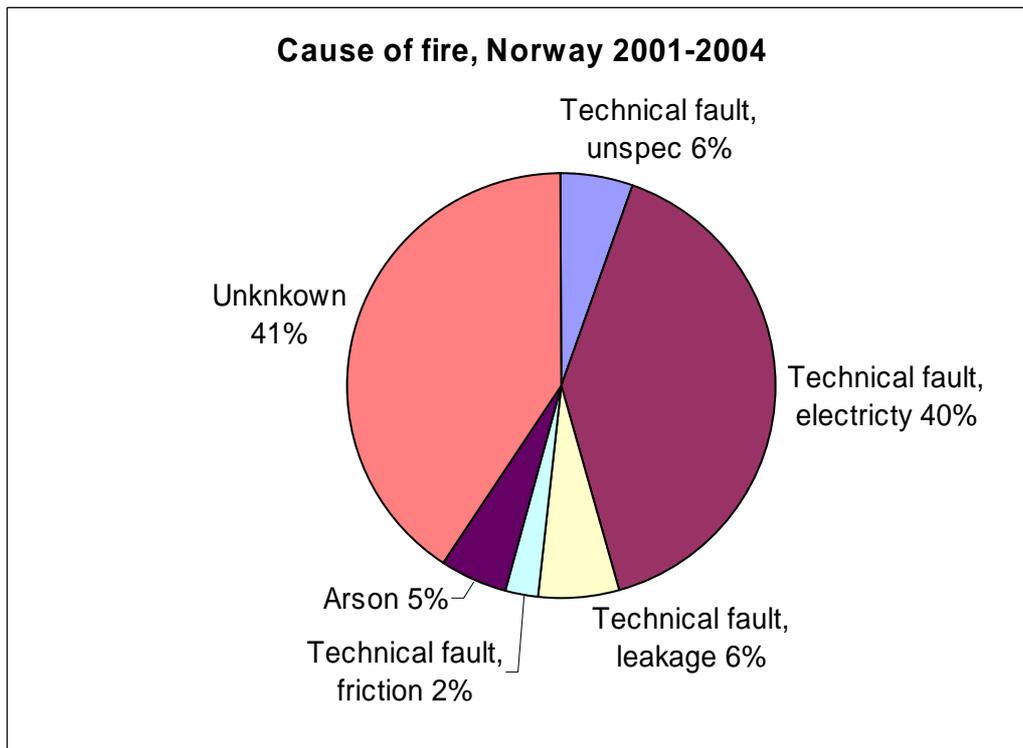
Figure 4. Breakdown of causes of fires over the period 2001–2004: Mean values.

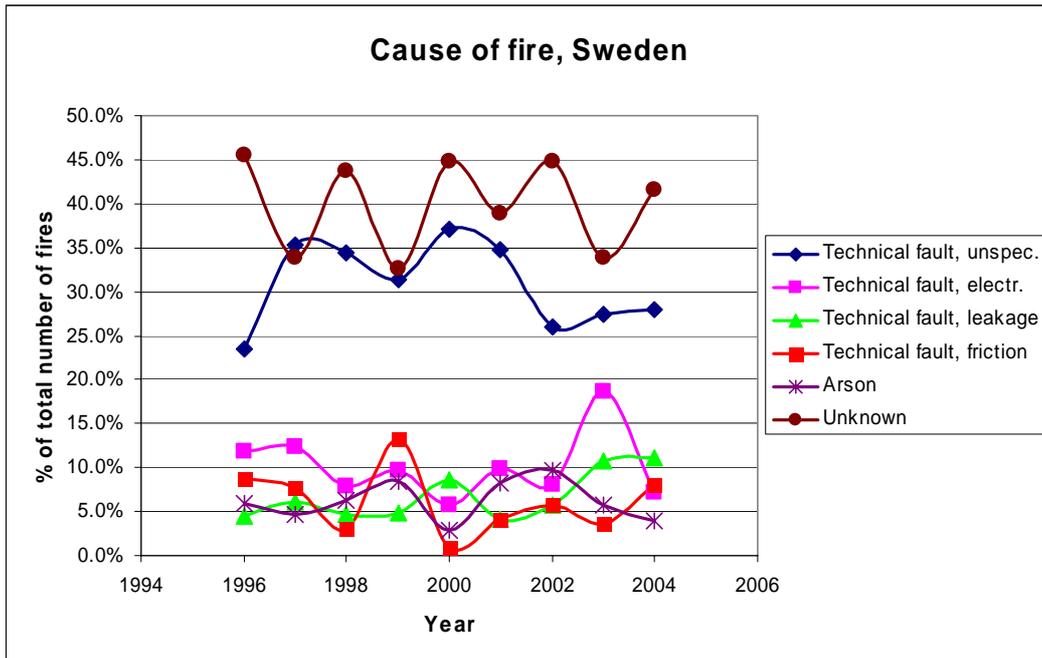
Figure 5 and Figure 6 show the reported cause of bus or coach fires in Sweden. The categories are the same as those for Norway (see above).

Figure 5. Causes of bus or coach fires in Sweden, 1996 - 2004.

Information on the causes of fires differs very considerably between Norway and Sweden, particularly for the category of ‘Technical Fault’, which Norway indicates as being responsible for about 40 % of fires, while Sweden cites it for only about 10 %. This indicates some uncertainty, particularly in the writing of event reports.

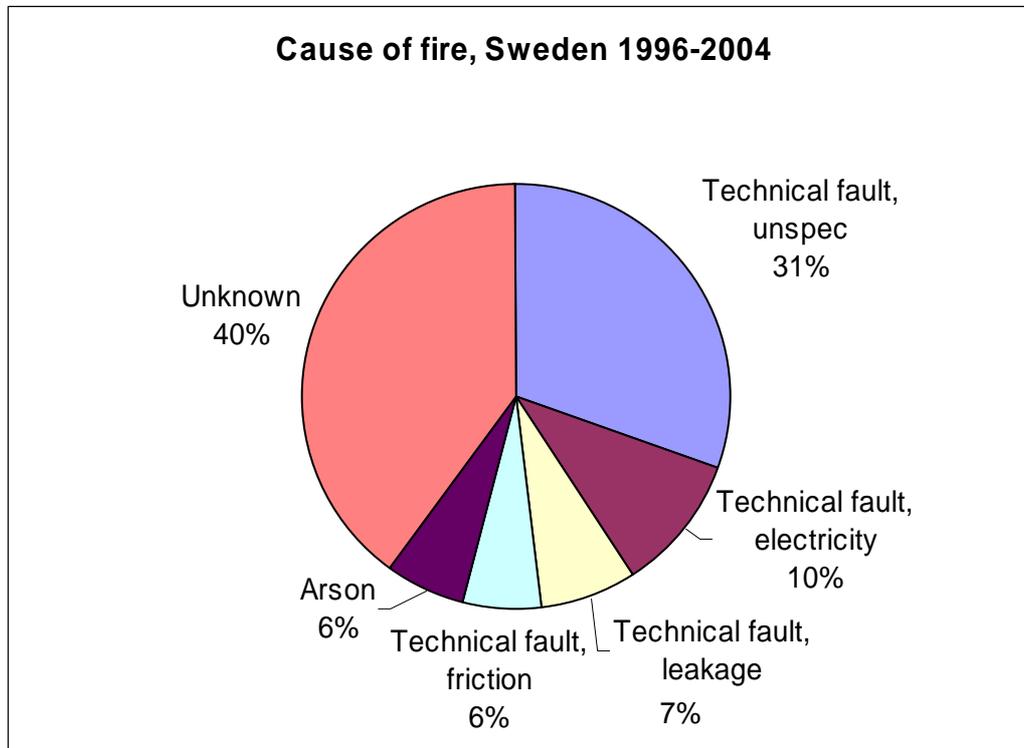
Figure 6. Breakdown of causes of fires in Sweden over the period 1996–2004: Mean values.

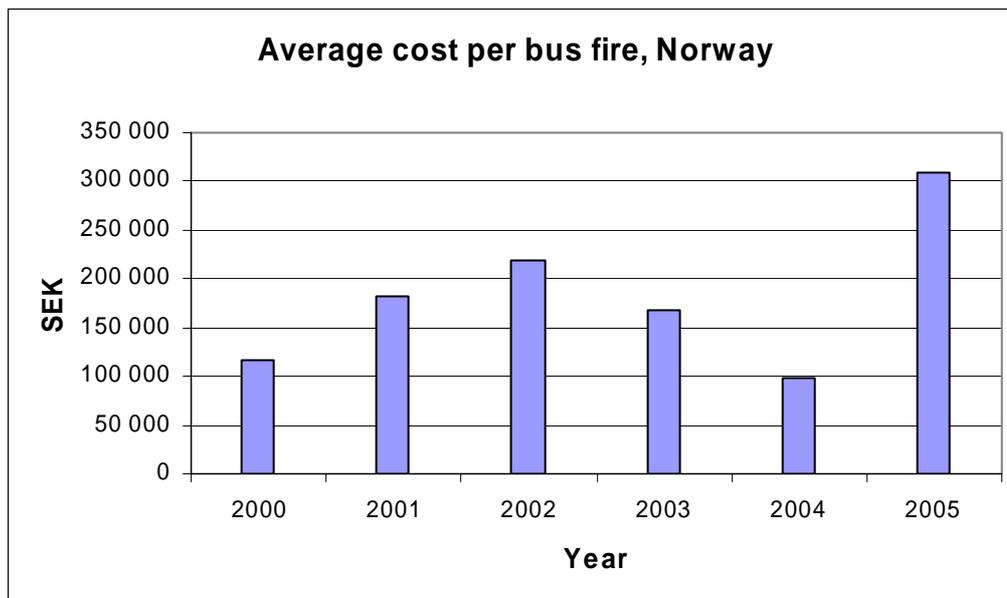
Figure 7 shows the average settlement payments in Norway over the period 2001–2004. In order to simplify comparison between Norwegian and Swedish conditions, all costs have been converted to Swedish crowns (SEK).

The average settlement payment is lower in Norway than in Sweden, and the apparent downward trend between 2002 and 2004 can be seen to be only temporary. If we ignore smaller settlements (below NOK 10 000), the average value of settlements increases by between 20 and 50 %. The information from 2005 covers only 10.5 months of the year, and represents a substantial increase in settlement payments.

Figure 7. Average cost (SEK) per bus/coach fire in Norway, 2000 - 2005.

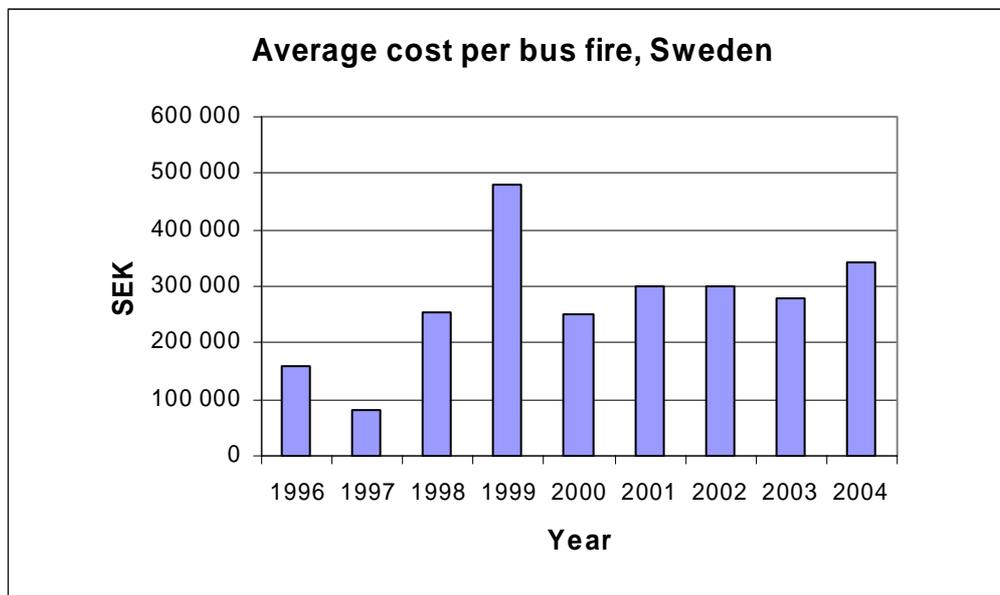
Figure 8 and Table 8 provide corresponding overviews of the size of settlement claims for bus/coach fires in Sweden, as provided by two insurance companies. Over the whole period, it can be seen that the average cost per fire is tending to increase. The peak in 1999 seems to be of temporary character. The average cost of fires is somewhat higher in Sweden than in Norway.

Figure 8. Average cost (SEK) per bus/coach fire in Sweden, 1996-2004.
